ADJUSTMENTS

DOOR ADJUSTMENTS

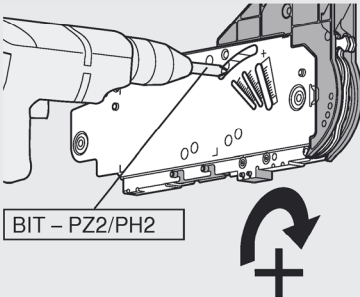
PROBLEM  
DOOR DROPS  
WHEN LET GO

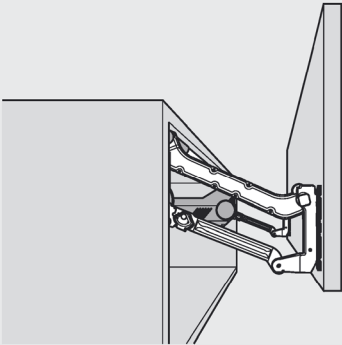
BIT – PZ2/PH2

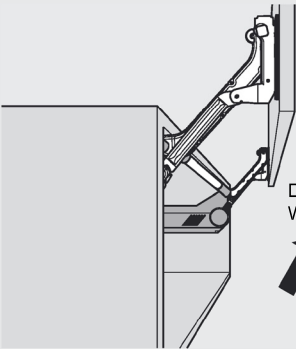
BALANCED

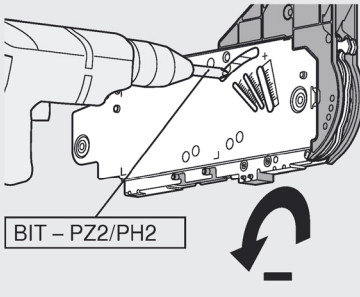
PROBLEM  
DOOR RAISES  
WHEN LET GO

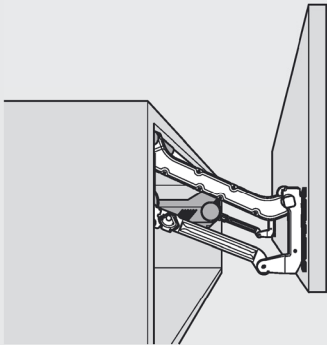
BIT – PZ2/PH2

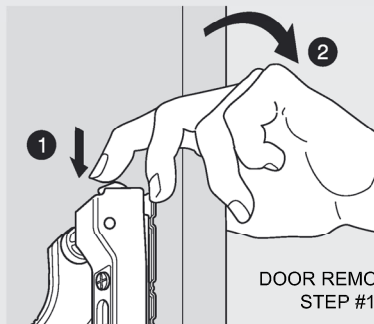
DOOR REMOVAL  
STEP #1

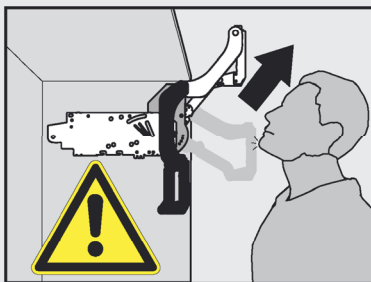
RISK OF INJURY FROM  
SPRING-LOADED LEVER ASSEMBLY!

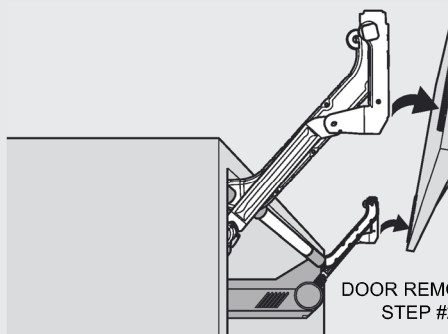
DOOR REMOVAL  
STEP #2

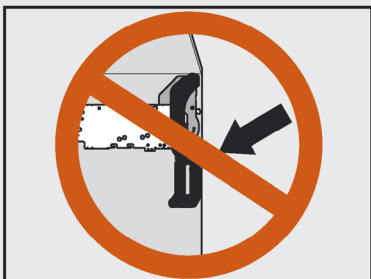
DO NOT PUSH  
SPRING-LOADED LEVER  
ASSEMBLY DOWN WITHOUT  
A DOOR ATTACHED!

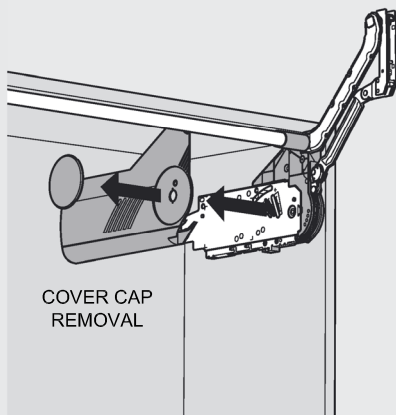
COVER CAP  
REMOVAL
