ADJUSTMENTS

DOOR ADJUSTMENTS

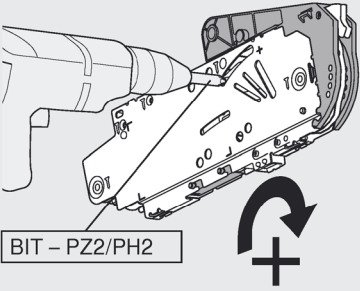
PROBLEM  
DOOR DROPS  
WHEN LET GO

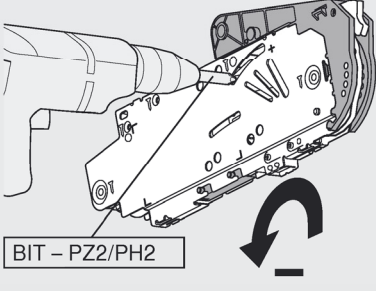
PROBLEM  
DOOR RAISES  
WHEN LET GO

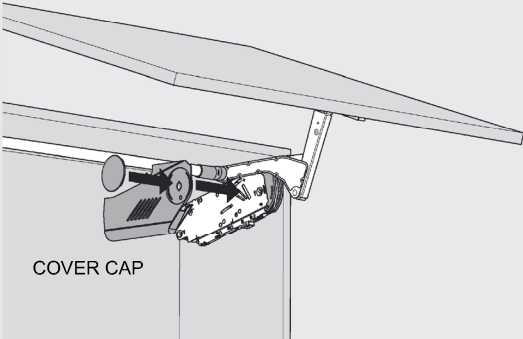
COVER CAP

± 2 mm    ± 2 mm    ± 2 mm

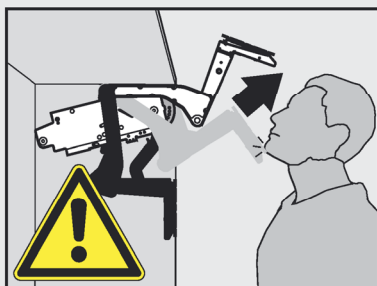
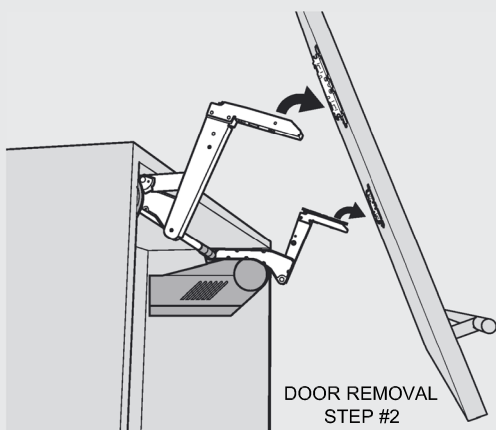
RISK OF INJURY FROM  
SPRING-LOADED LEVER ASSEMBLY!

DO NOT PUSH  
SPRING-LOADED LEVER  
ASSEMBLY DOWN WITHOUT  
A DOOR ATTACHED!
